Fort Riley,
Building # 117
117 Lower Brick Row
Fort Riley
Riley County
Kansas

HABS No. KS-54-K

HISTORIC AMERICAN BUILDINGS SURVEY
FORT RILEY, BUILDING # 117

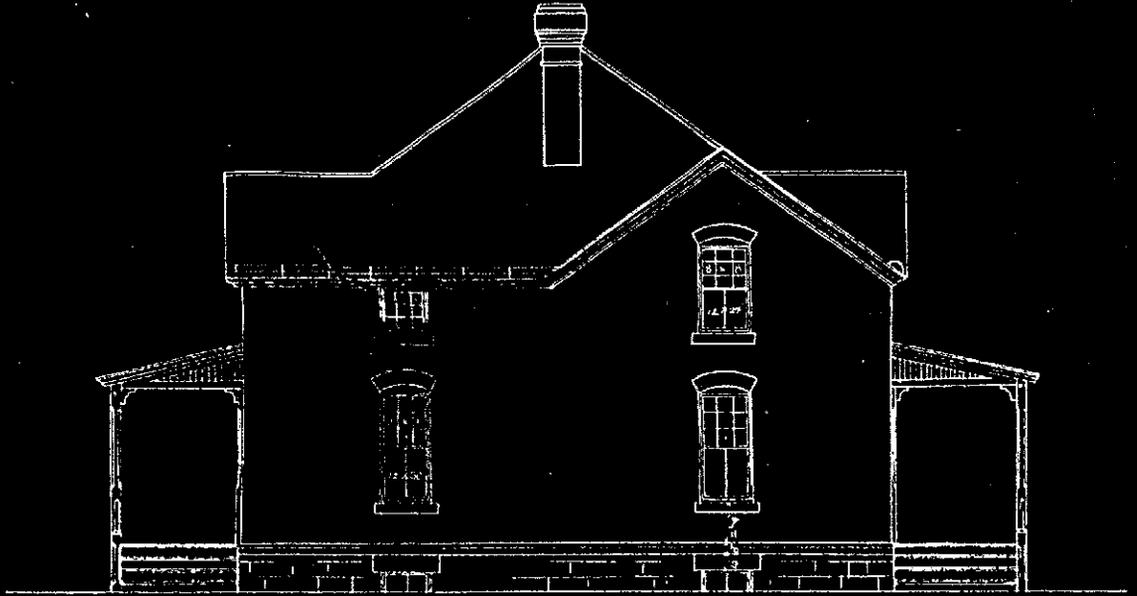
1. Front Elevation and Basement

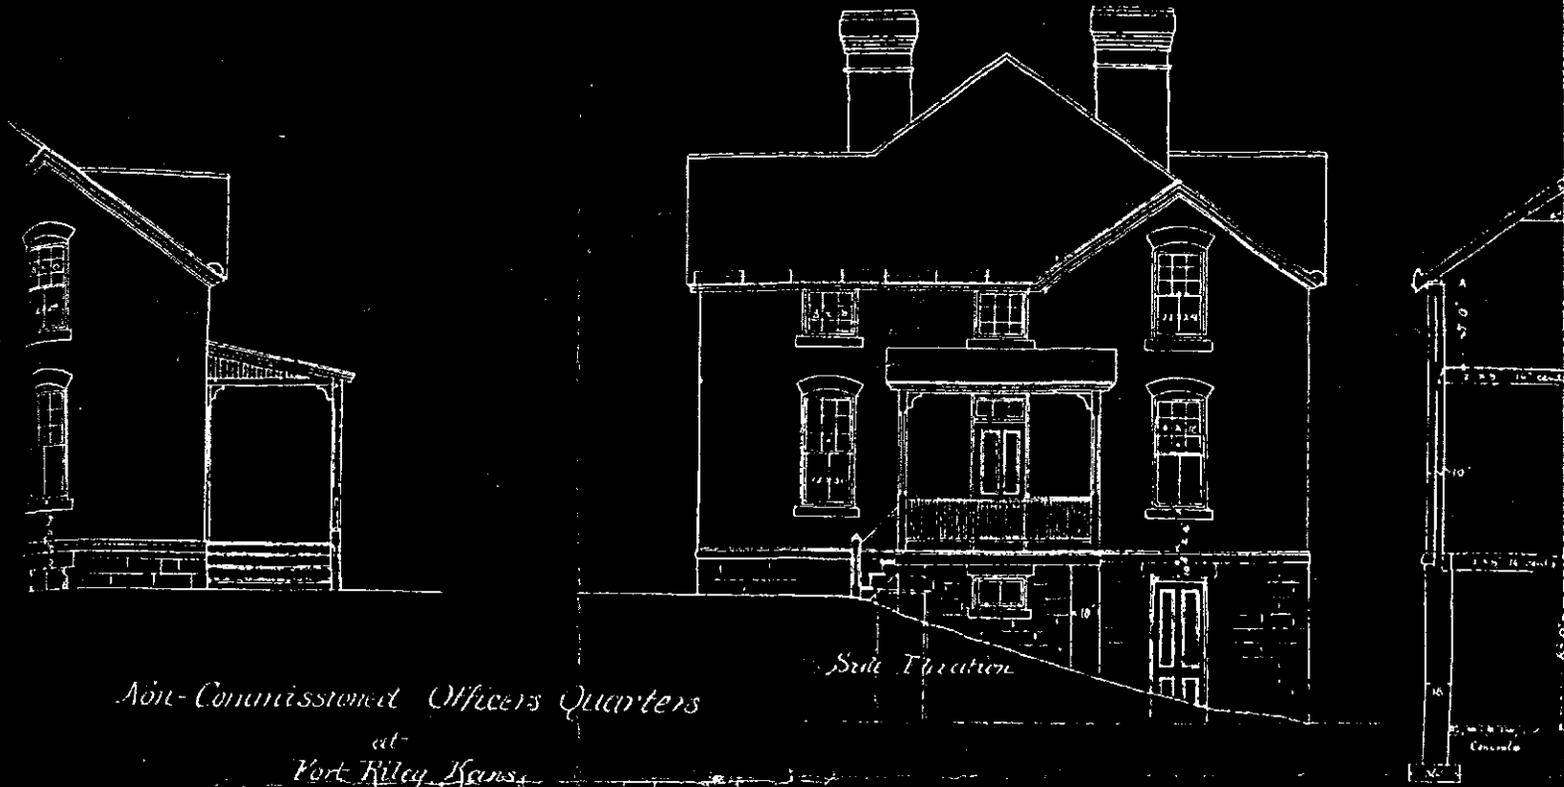
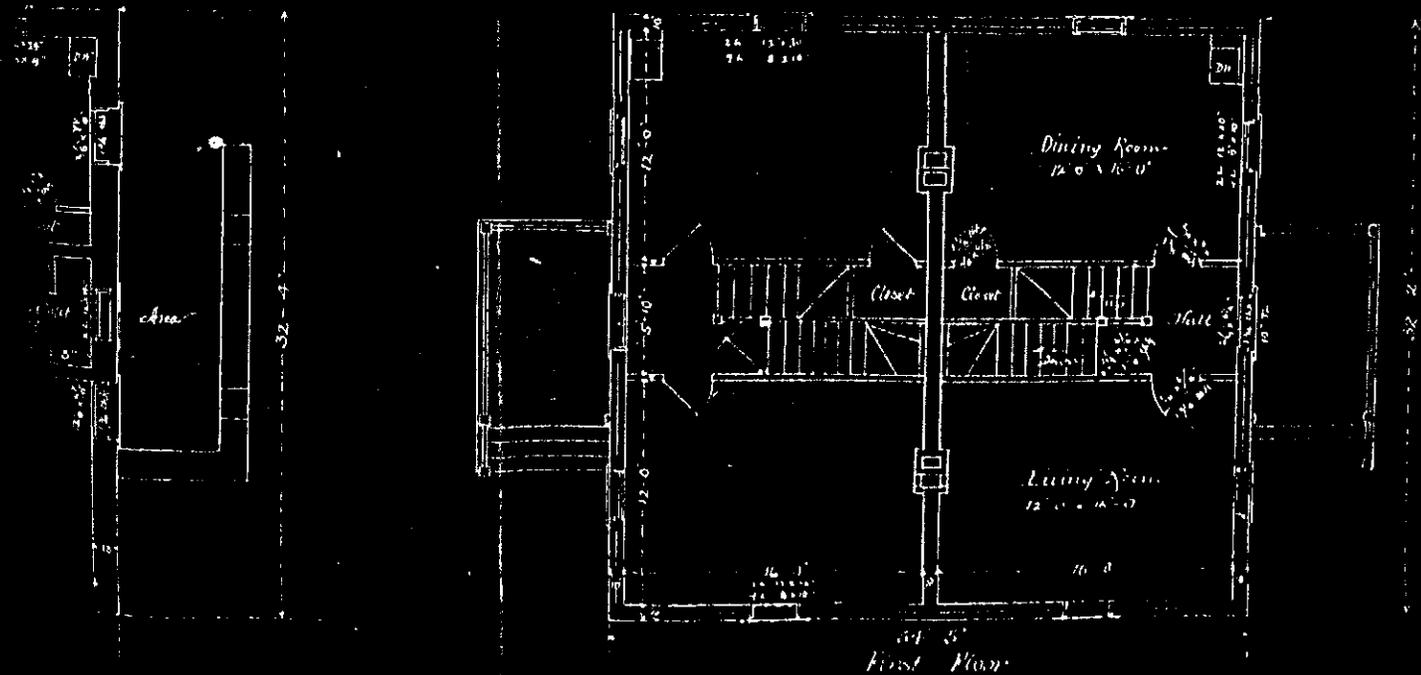
2. Side Elevation and First Floor

Non-Commissioned Officers Quarters
at
Fort Riley, Kansas

Scale 1/8" = 1'

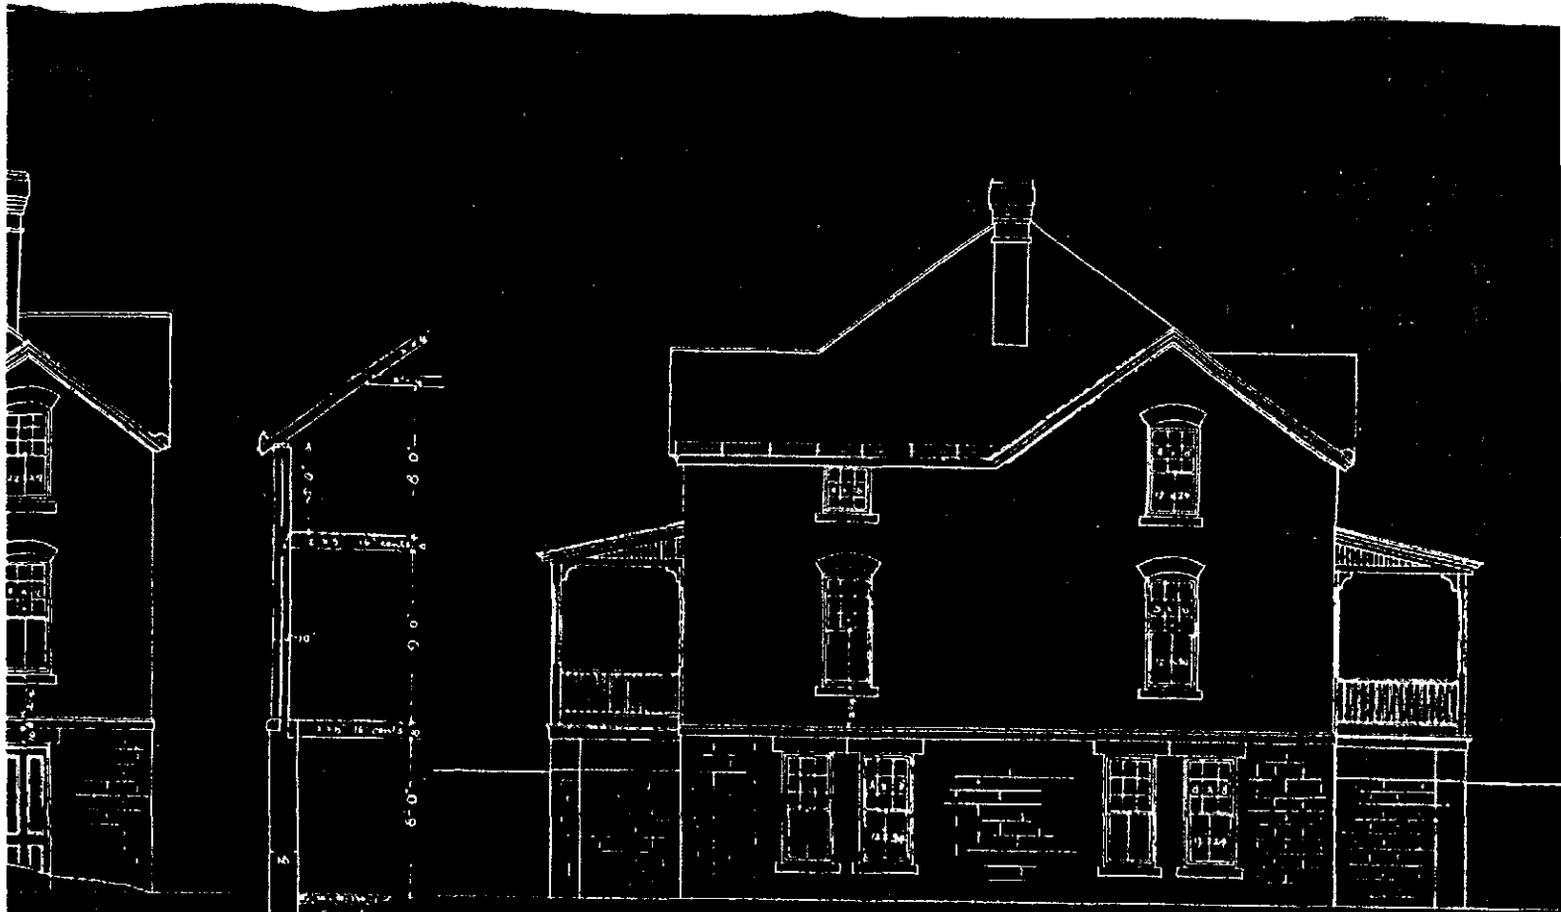
3. Rear Elevation and Second Floor

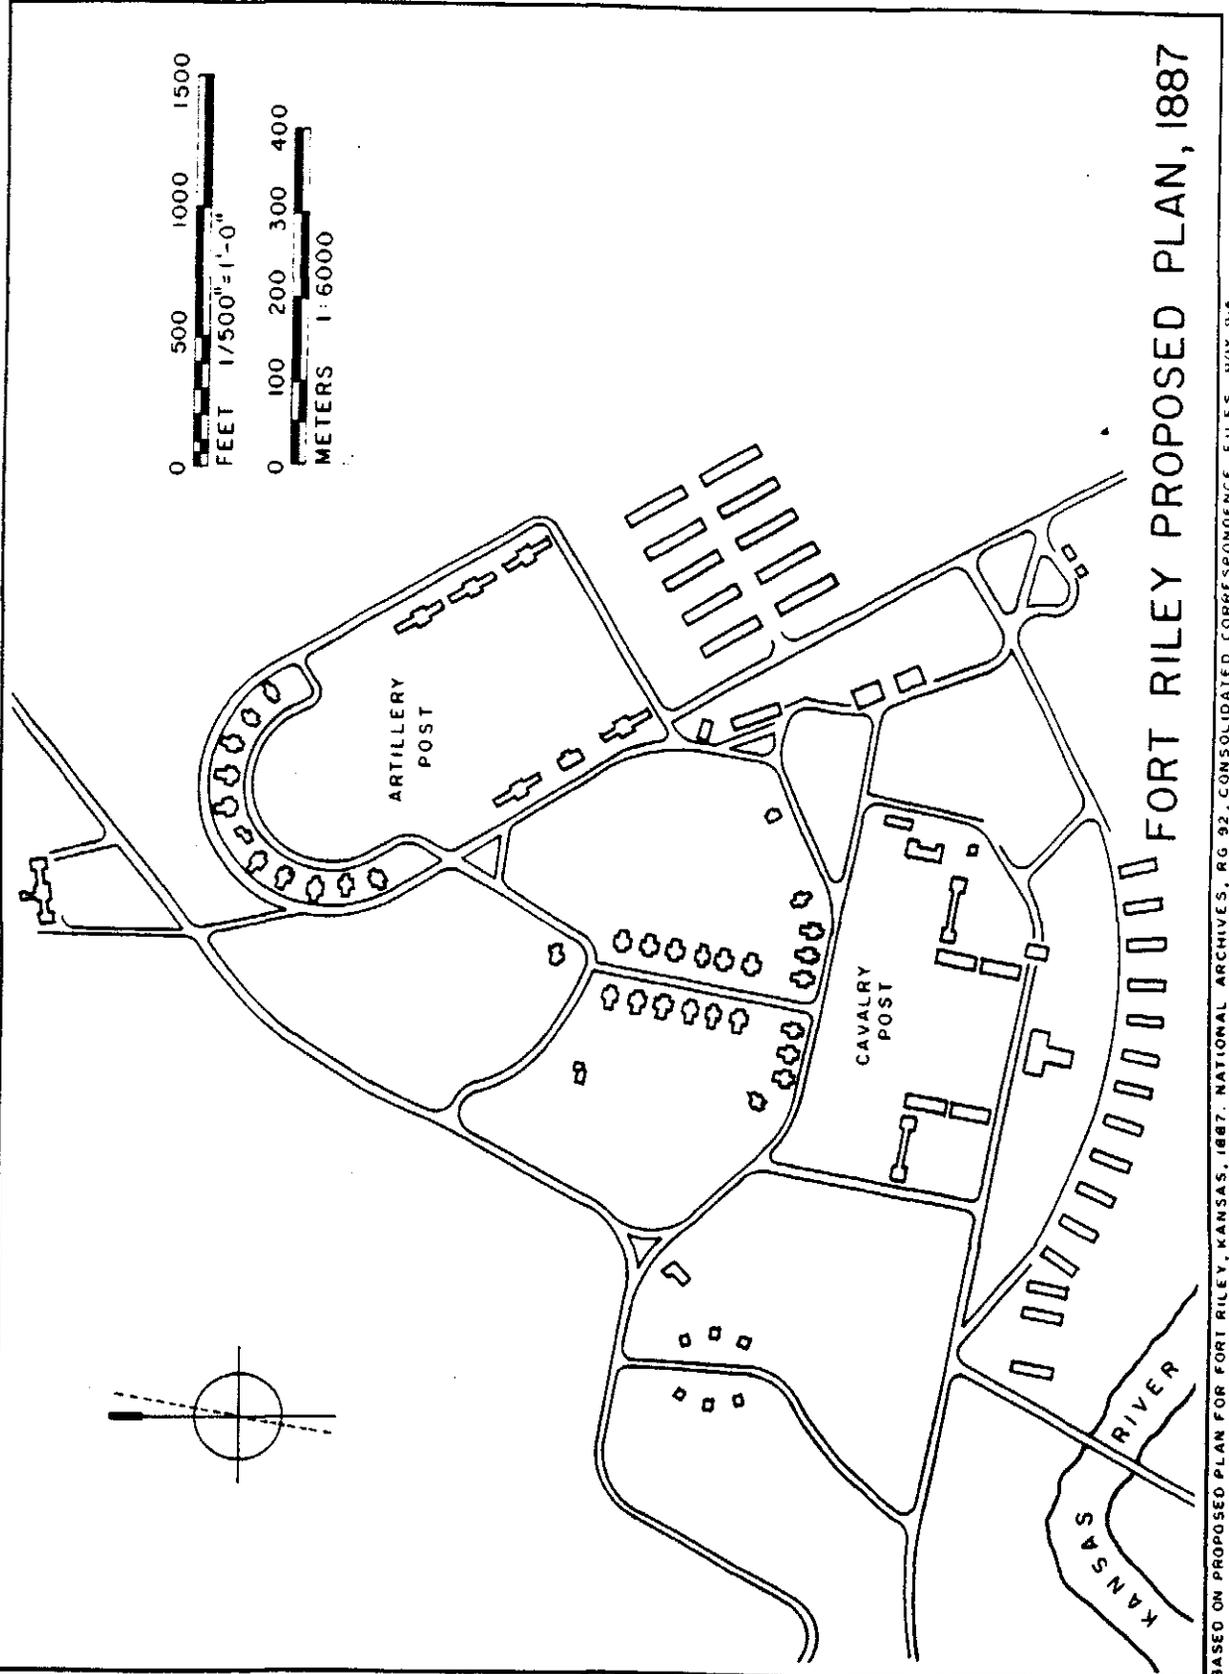
PROPOSED PLAN, 1887 AND SITE PLAN, 1985

6. Fort Riley, Proposed Plan, 1887

BASED ON PROPOSED PLAN FOR FORT RILEY, KANSAS, 1887. NATIONAL ARCHIVES, RG 92, CONSOLIDATED CORRESPONDENCE FILES, BOX 915.
